# Safety Inspection Report

## Williton Memorial Ground

Williton Parish Council

09 July 2025

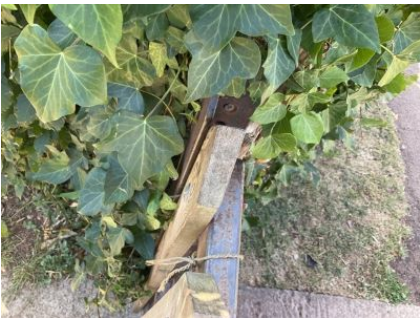
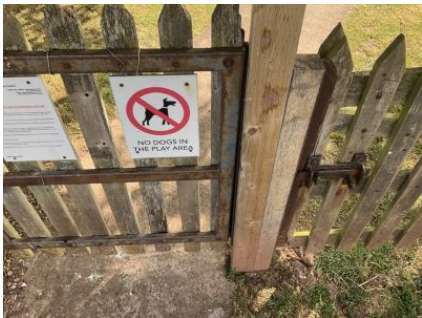
There is a crushing or shearing point on the side of the gate. Where the gaps reduce to less than 12 mm these have been known to cause serious, permanent injury to children, especially on the hinge side where the leverage forces are significant.

Adjust gate / posts / fit new rubber buffer to ensure a spacing of at least 12 mm throughout the range of the gate to remove the entrapment. The 12 mm gap also should apply on the hinge side of the gate.

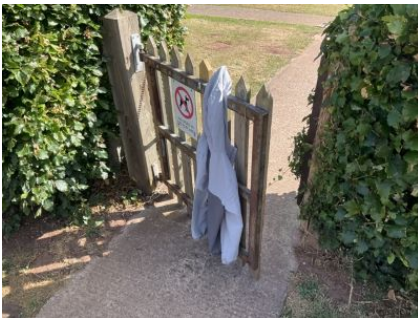
The gate's closing mechanism does not work correctly.

Adjust to allow gate to self close. Ideally gate from open should not close in less than 5 seconds.

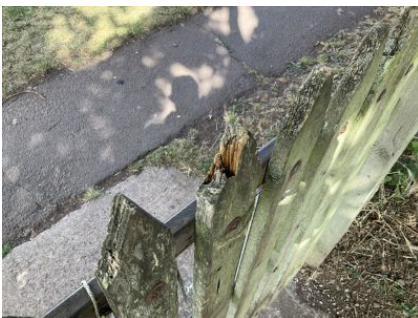
Timber is decayed.

Check on a routine basis.

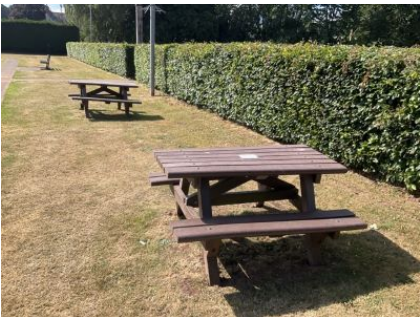
Item is rocking.

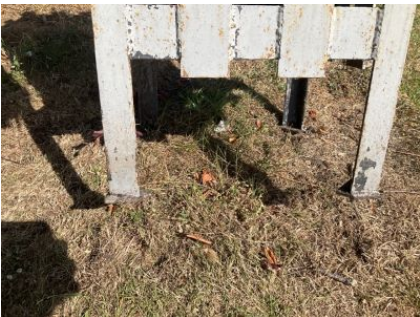
| Description |
|---|
| Item is not secure. |

| Description |
|---|
| Secure. |

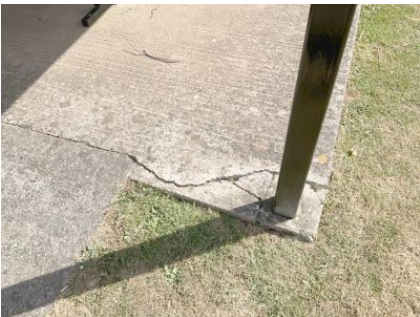
The surface is cracking.

Repair.

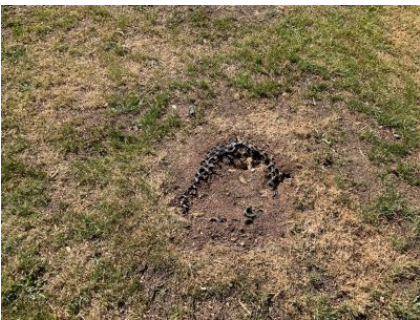
| Surface needs repair. |
| Surface damaged where old multiplay has been removed. |

| Repair. |

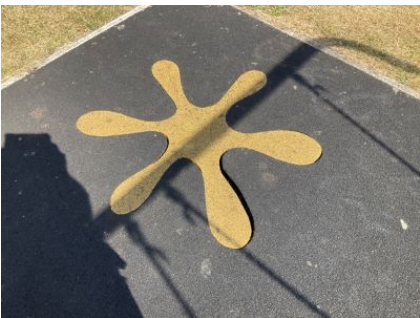
The wet pour surface is separating at the joints.

Repair.

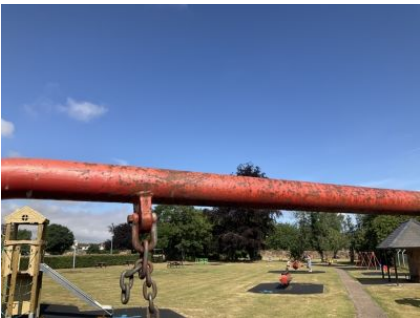
Paintwork is in poor condition.

De-scale back to good base material and coat with lead free paint, using appropriate precautions. Repairs may be necessary where corrosion is severe.

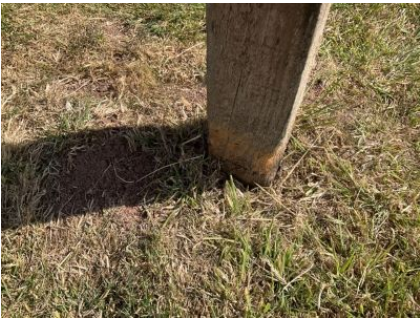
Timber is decayed.

Strimmer damage and decay.

Prevent further damage., Check on a routine basis.

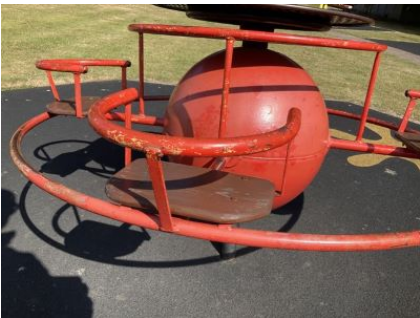
There is a head entrapment.

The unit was installed prior to the publication of the current standards. There is no requirement to make retrospective changes.

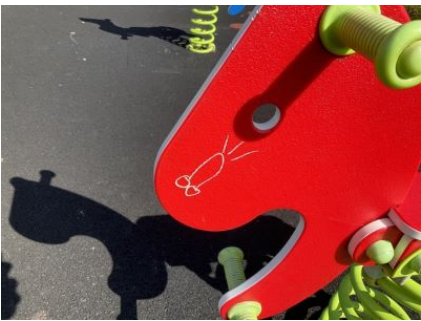
There is offensive graffiti on the unit.

Remove.

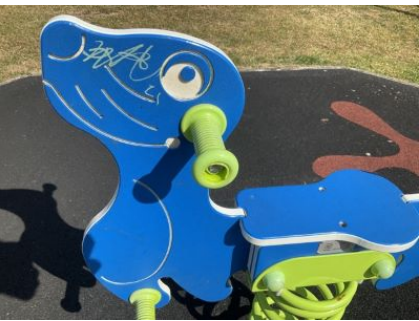
Cap missing.

Replace.

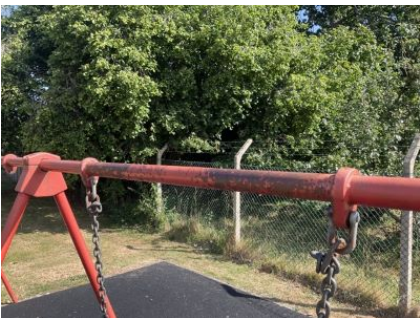
Item has corrosion.

Treat and repair.

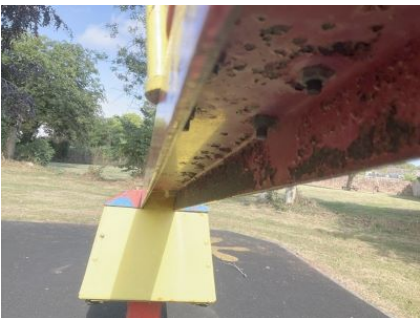
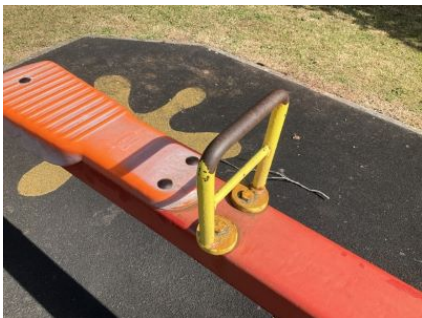
Item has corrosion.

Treat and repair.

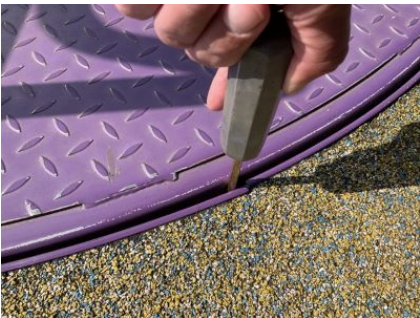
| Description | Tasks | Risk score |
|---|---|---|
| The flush carousel has gaps exceeding that permitted. The gap must be less than 8 mm. | Modify to meet the standards. | 8 |

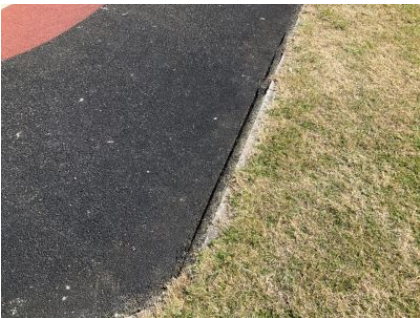
Shrinkage / separation of the surface. This may give a trip hazard.

| Description | Tasks | Risk score |
|---|---|---|
| Shrinkage / separation of the surface. This may give a trip hazard. | Re-glue and fill gaps and joints as necessary. | 3 |
