# Safety Inspection Report

## Williton Memorial Ground

Williton Parish Council

09 July 2025

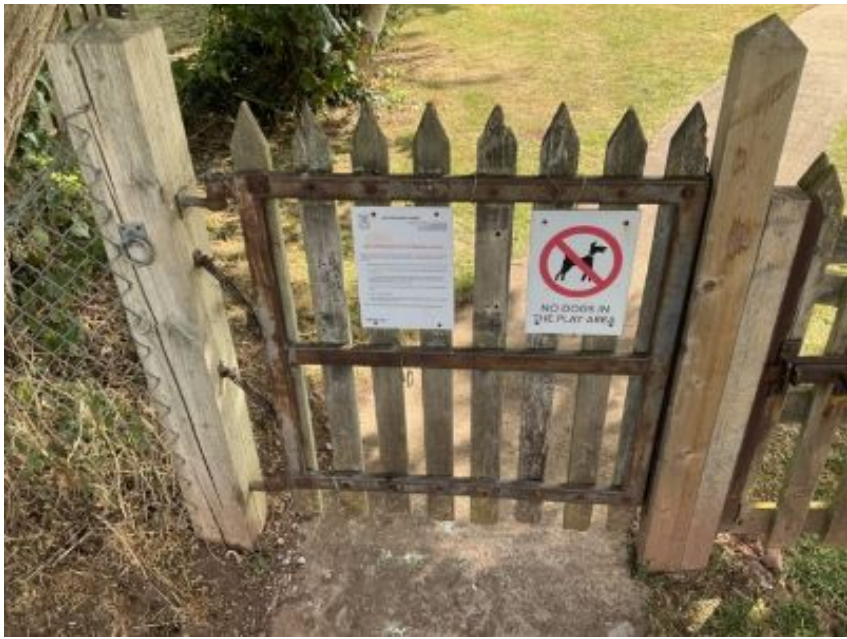
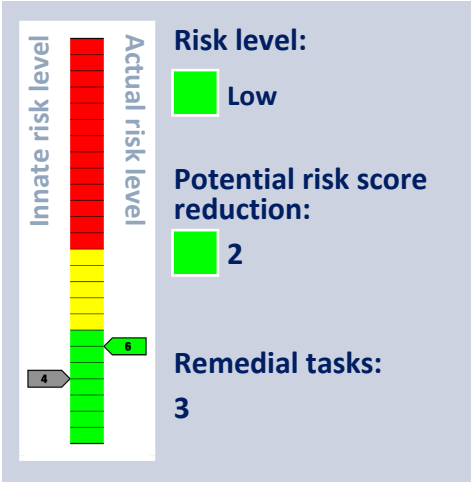
# Gates

There is a crushing or shearing point on the side of the gate. Where the gaps reduce to less than 12 mm these have been known to cause serious, permanent injury to children, especially on the hinge side where the leverage forces are significant.

Timber is decayed.

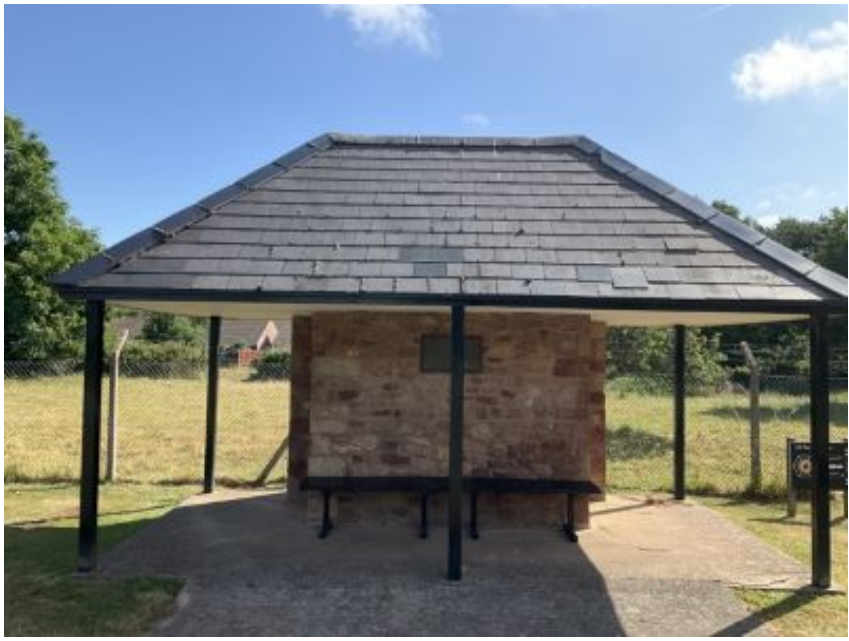
# Shelter

The surface is cracking.

Repair.

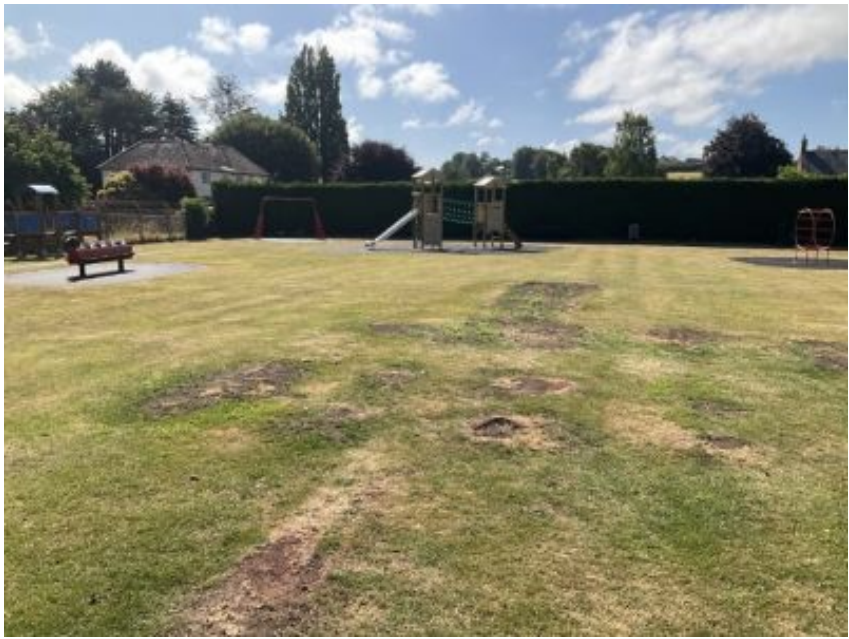
# General Surface - Grass

| Surface needs repair. |
| Surface damaged where old multiplay has been removed. |

| Repair. |

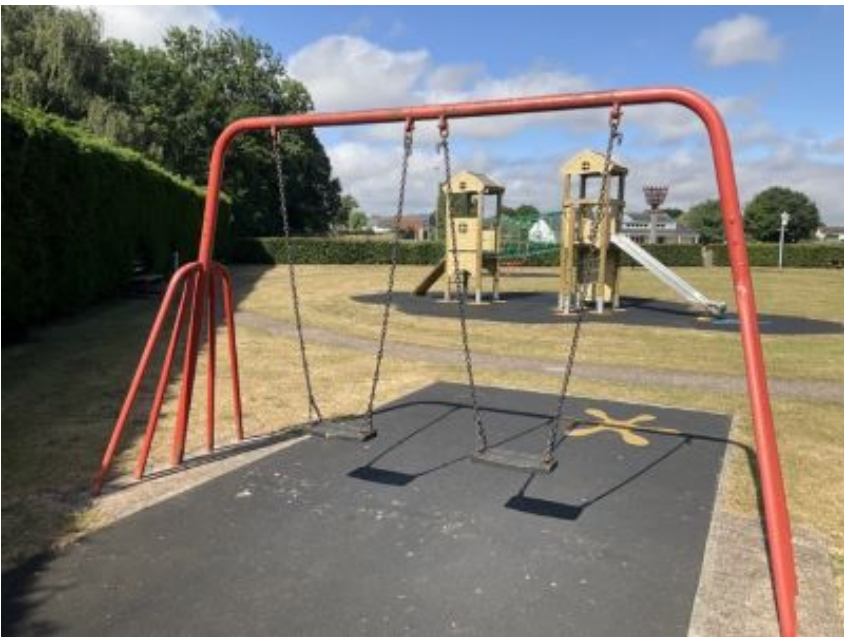
# Swing - Junior - 1 Bay 2 Seat

Paintwork is in poor condition.

Repair.

De-scale back to good base material and coat with lead free paint, using appropriate precautions. Repairs may be necessary where corrosion is severe.

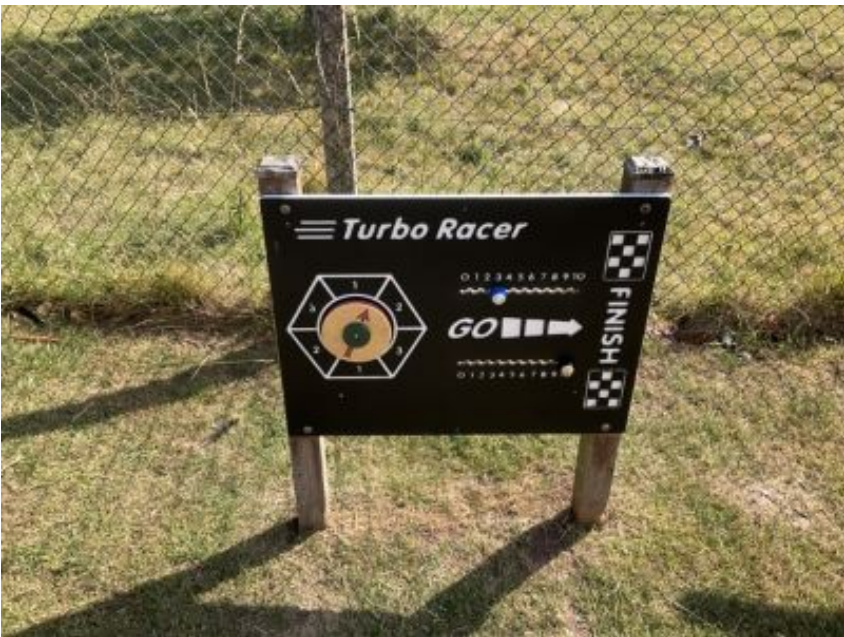
# Play Panel

Timber is decayed.

Strimmer damage and decay.

Prevent further damage., Check on a routine basis.

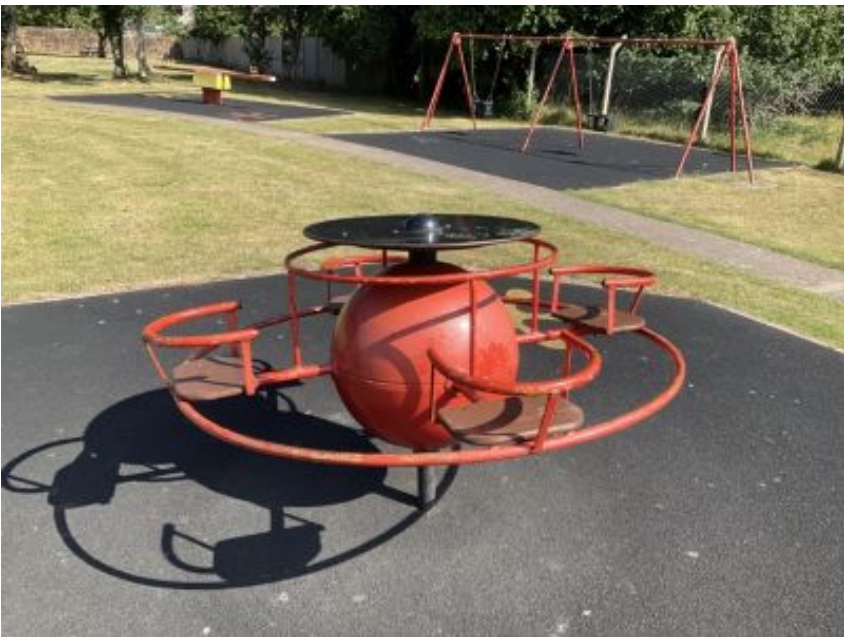
# Carousel - Sputnik

- Equipment Standard Compliance Findings
1. There is a head entrapment.

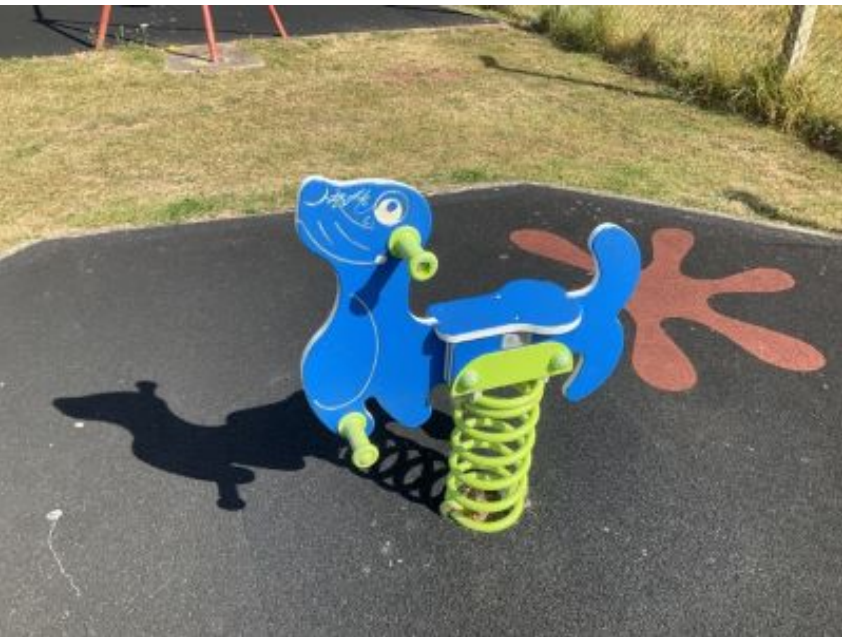
# Rocker - Seal

Cap missing.

Replace.

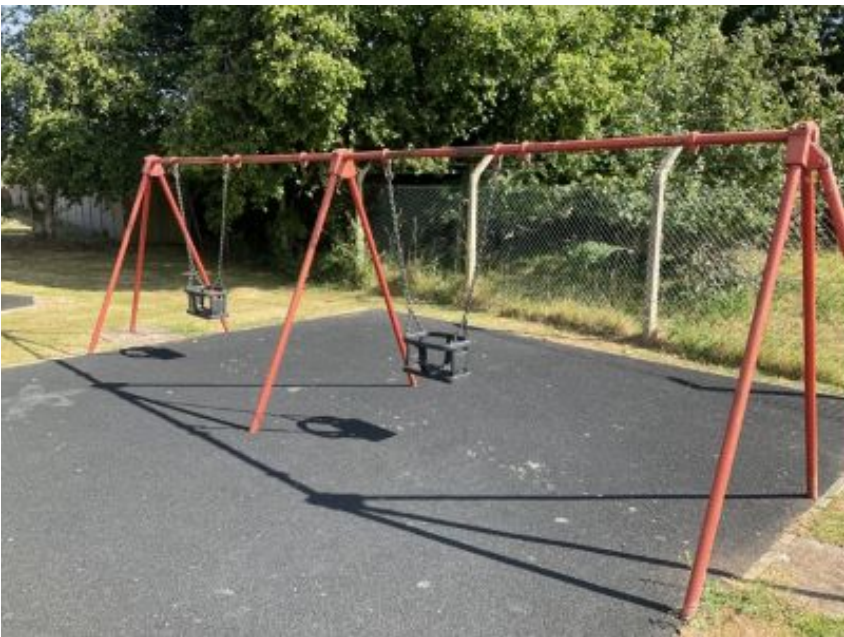
# Swing - Toddler - 2 Bay 4 Seat

Item has corrosion.

The swing suspension(s) are missing.

Treat and repair.

Replace the missing parts, ensuring a safe installation.

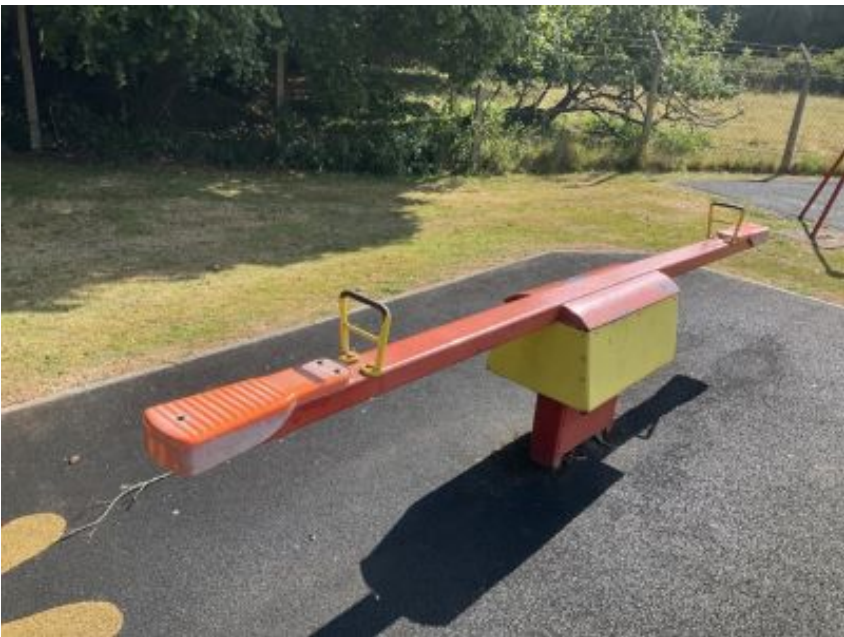
# Rocker - Seesaw

Item has corrosion.

Treat and repair.

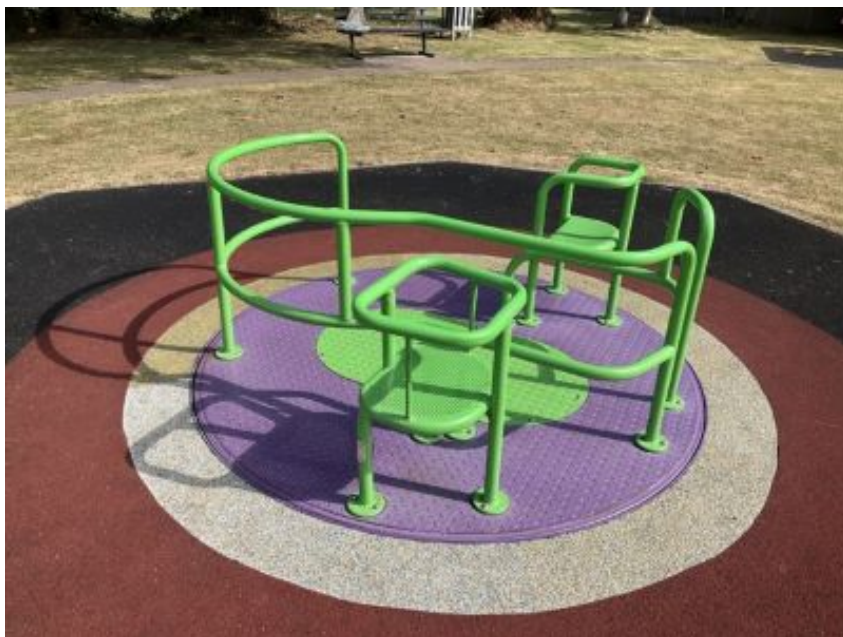
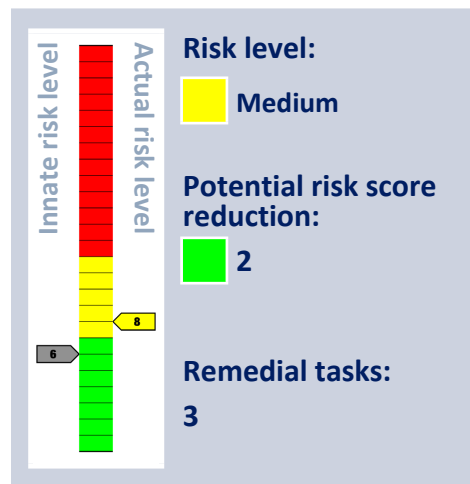
# Carousel - Flush

1. Shrinkage / separation of the surface. This may give a trip hazard.
2. Bearings require service.

Shrinkage / separation of the surface. This may give a trip hazard.
